TWR-18076

Field Joint Protection System Rain Qualification Final Test Report

11 May 1989

MORTON THIOKOL, INC.

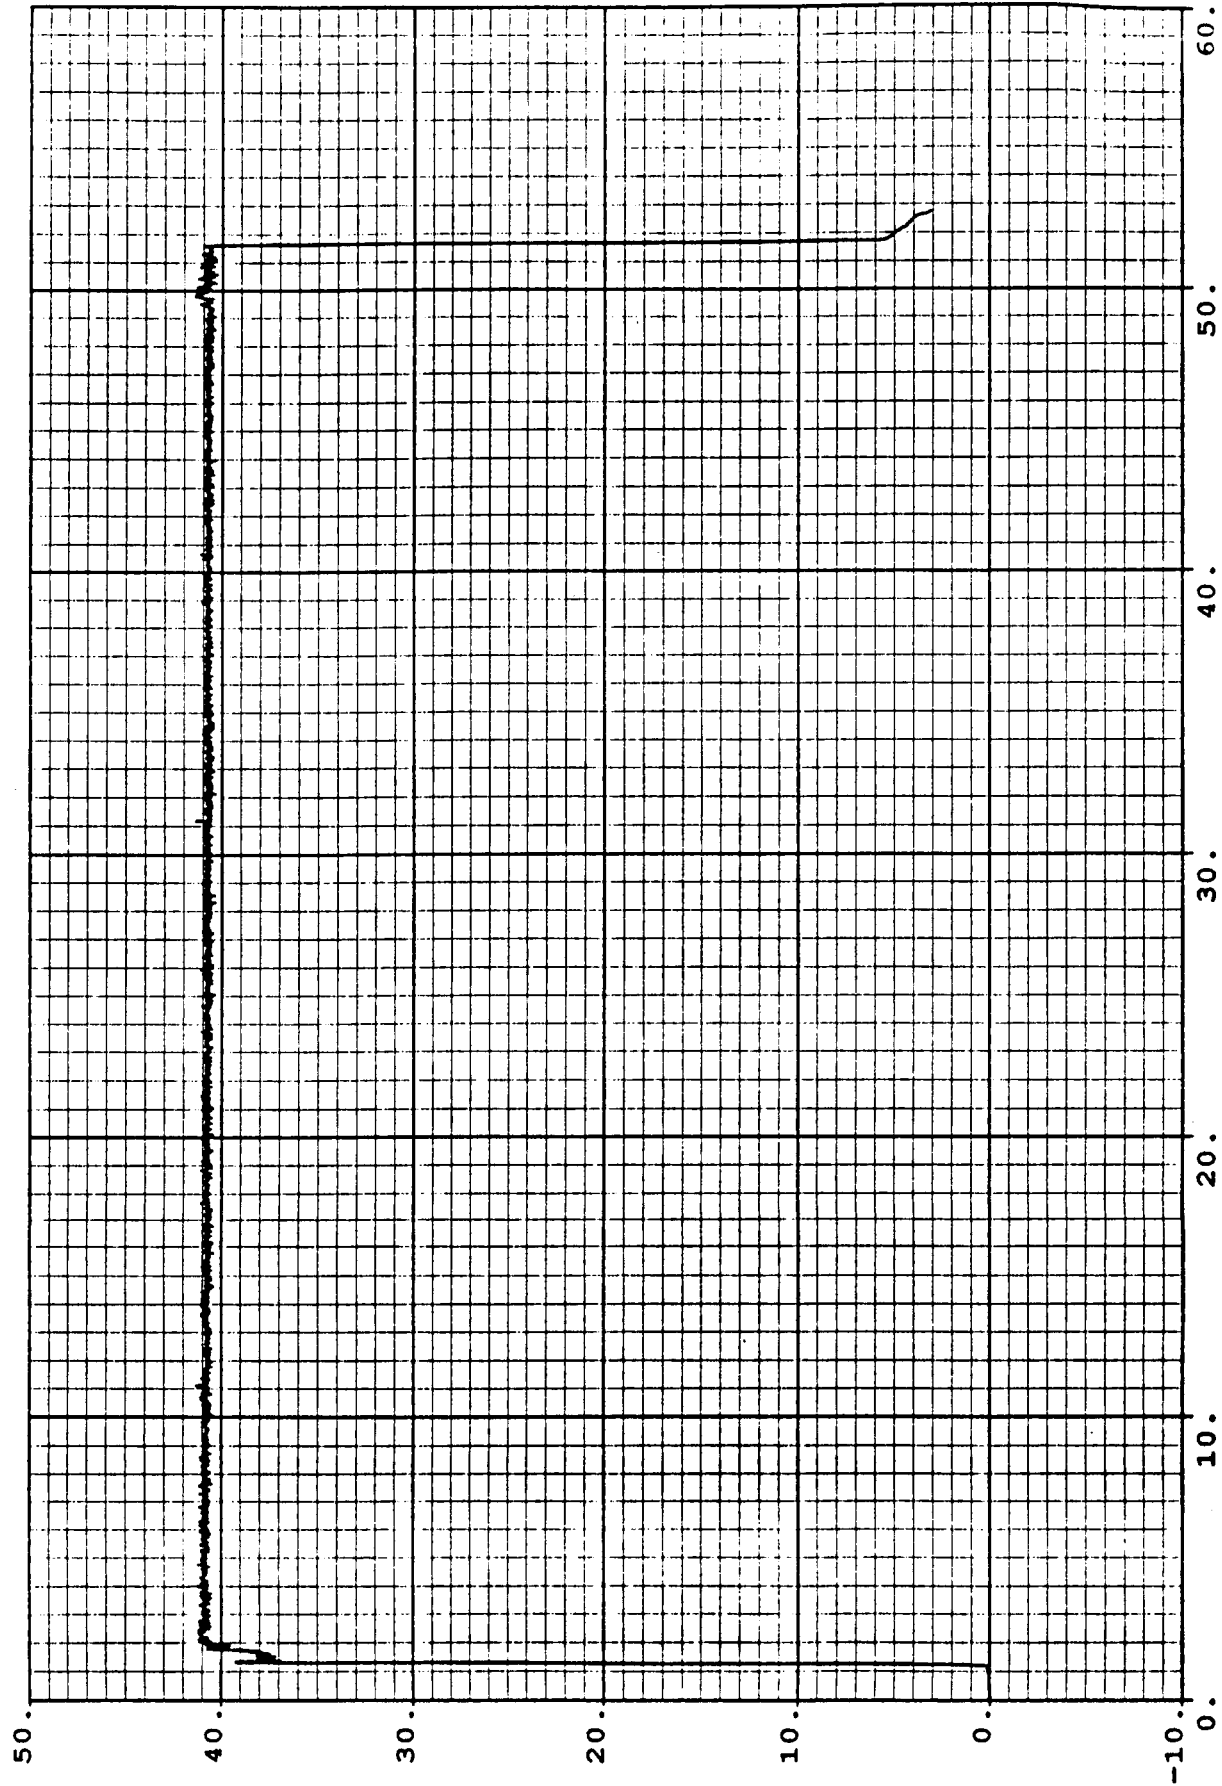
P001 Water Pressure

Three pressure gages (P001, P002, P003, locations shown in Figure 4) were used to monitor test fixture water pressure, and the results are included in the appendix. P001 was damaged at approximately 30 minutes into the test due to water in the gage connector. However, results of the other two gages show that constant water pressure (approximately 41 psi) was maintained throughout the test.
